Building Inspection Report

Inspection Date: Tue, 16 Jan 2024

Property Address: 7 Kurrajong Rd, Frenchs Forest NSW 2086

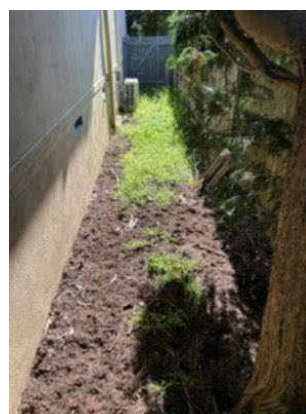
Defects 3.01

Building:	Building 1
Location:	All External Areas/ subfloor
Finding:	Evidence of excessive moisture was present at the time of inspection
Information:	Excessive moisture can attract termites and produce conditions that promote termite attack fungal growth and wood decay.

Excessive moisture is generally caused by deteriorated inadequate or missing roof drainage leaking plumbing pipes or fixtures poorly plumbed HWS overflows or condenser units and poor site drainage.

It is highly recommended that all plumbing and drainage fixtures and fittings be maintained regularly in order to prevent excessive moisture being present in the external / internal property.

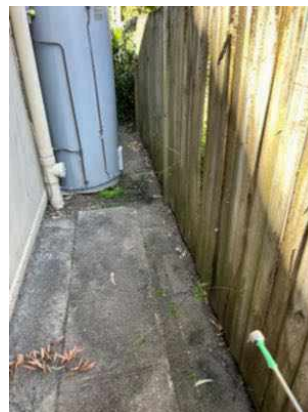
Defects 3.02

Building:	Building 1
Location:	All External Areas
Finding:	Site drainage - suspected Inadequate
Information:	The site drainage in this area was found to be inadequate at the time of inspection, creating potential for subsequent water damage to associated building elements.

Where site drainage is inadequate, installation of an Agricultural (Aggie) Drain may be required. A qualified plumber should be appointed to further inspect the property and perform any remedial works as necessary. Water damage and secondary defects are likely to occur if left unmanaged.

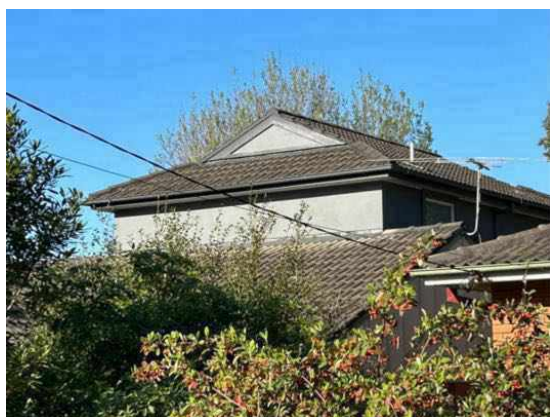
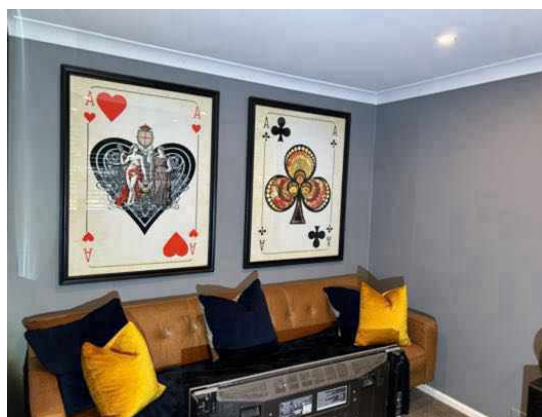
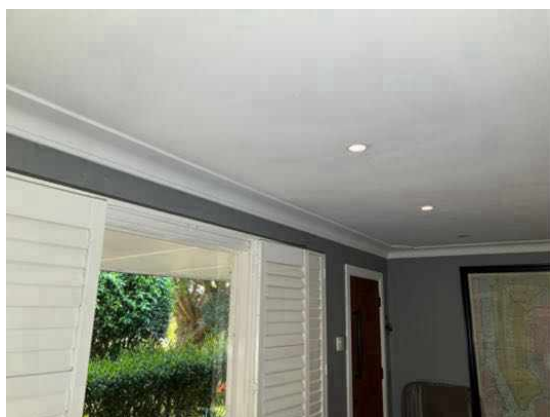
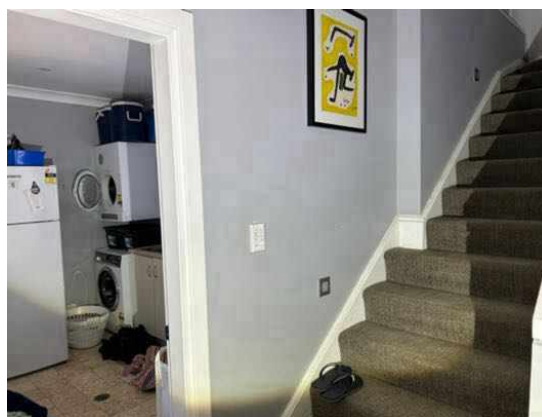
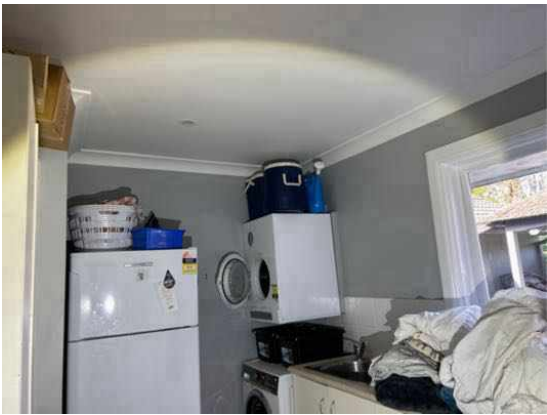
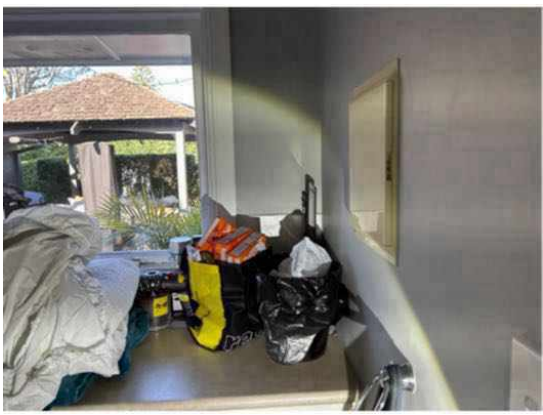
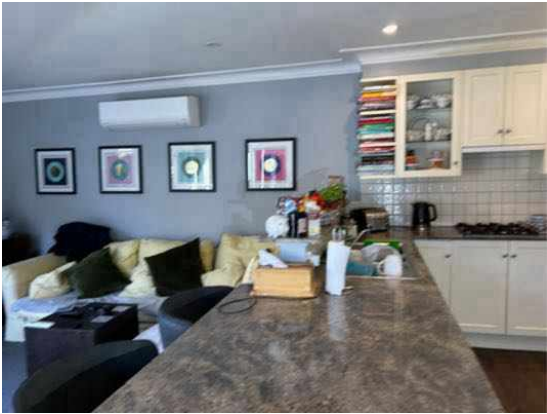
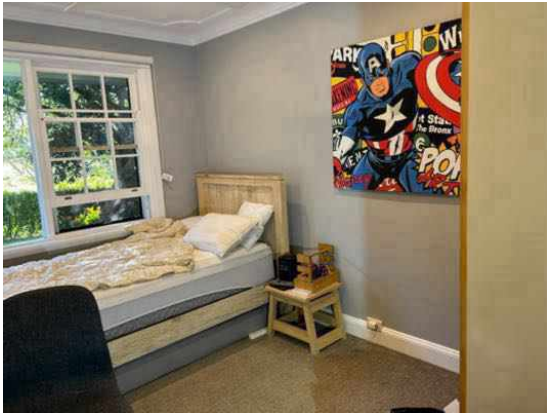
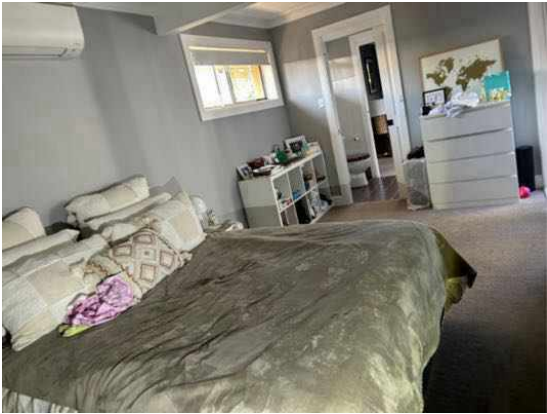
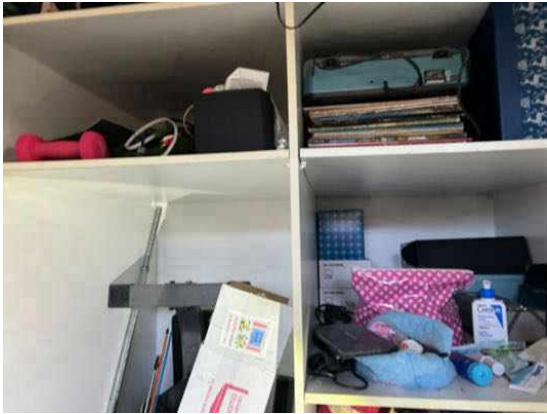
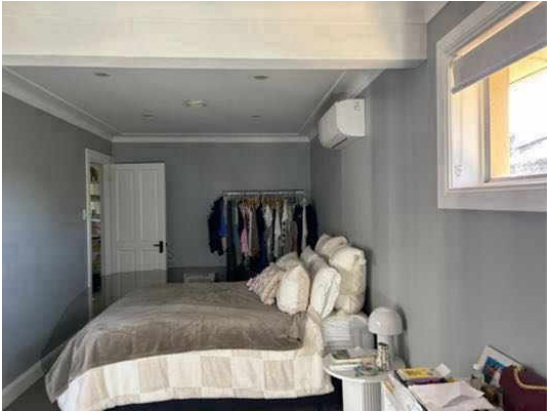
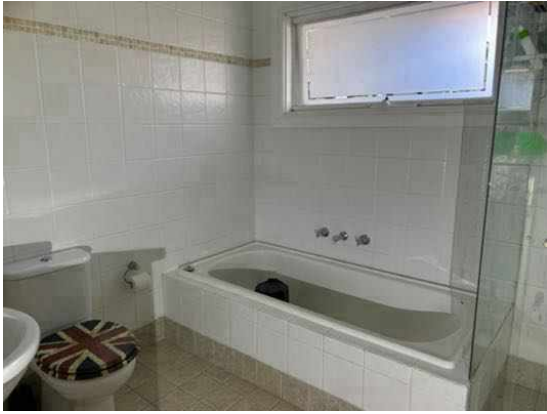
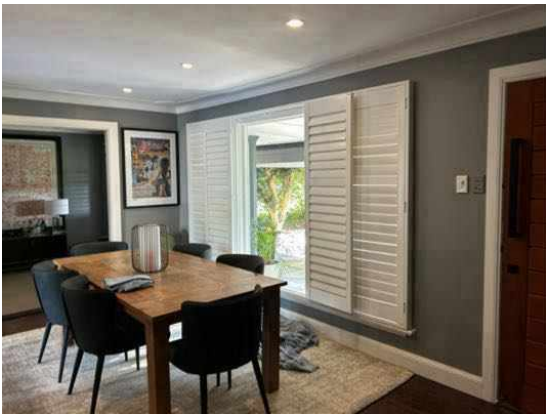
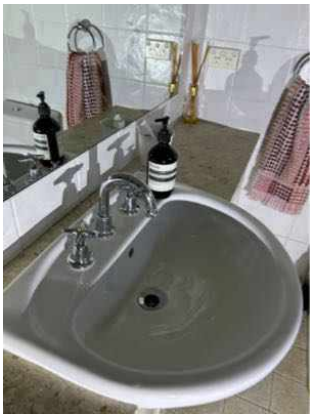
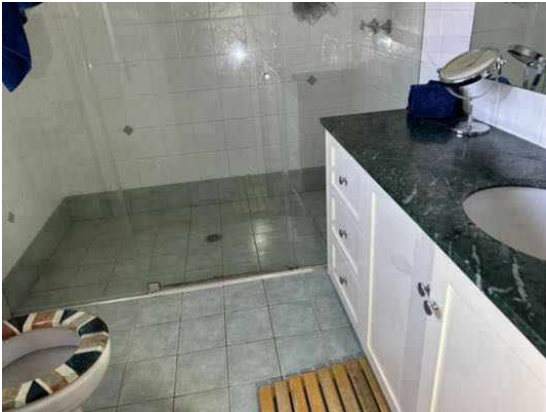
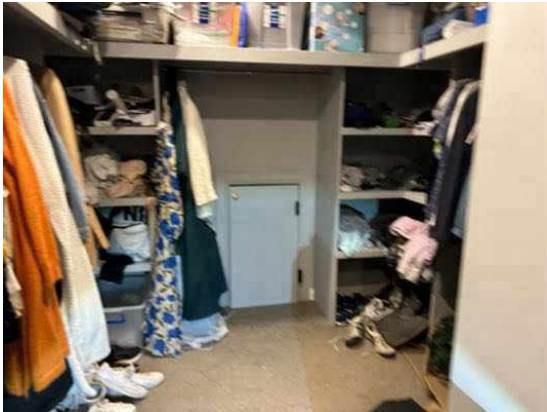
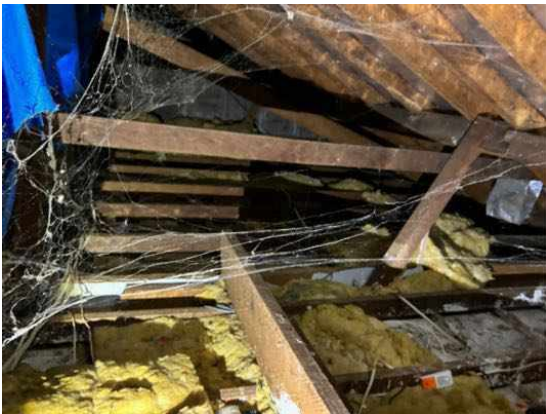
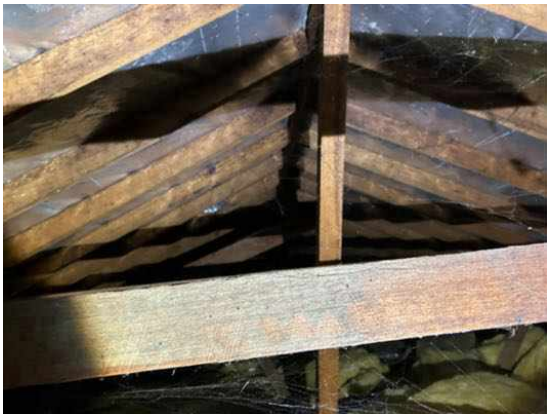
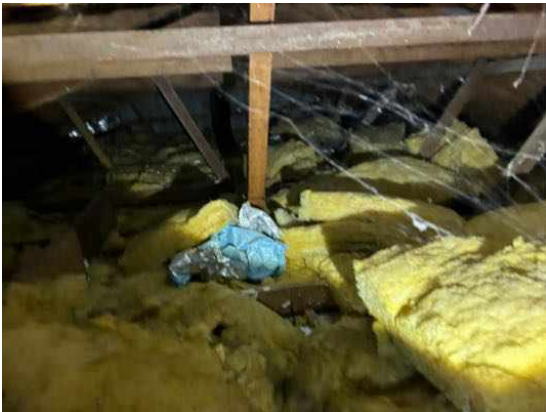
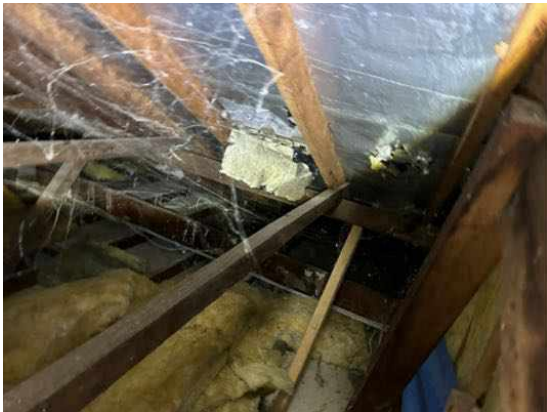
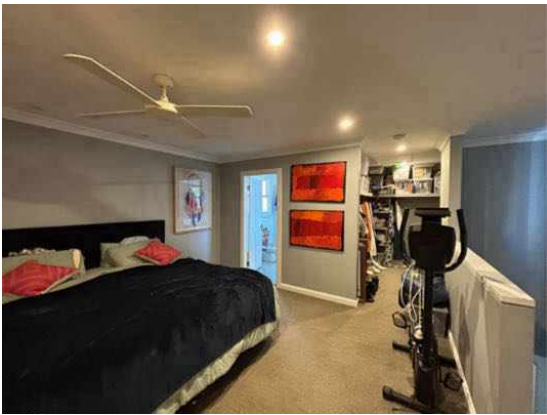
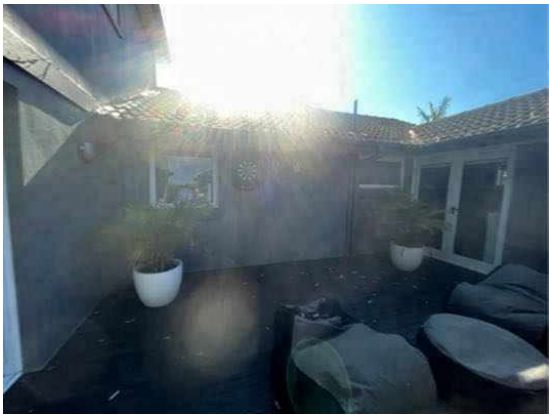
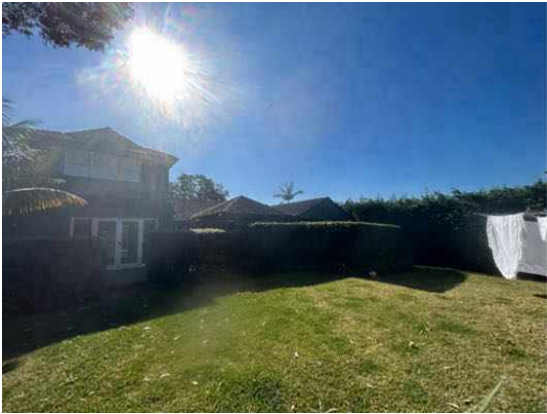
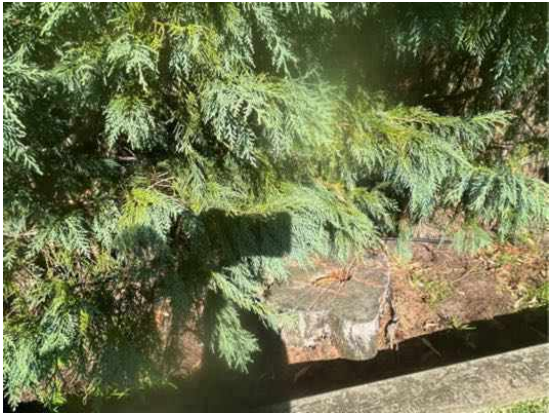
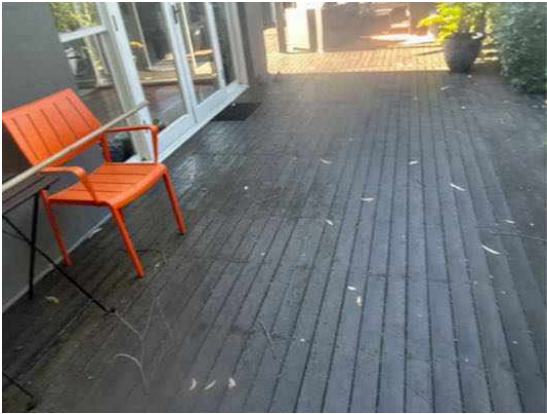
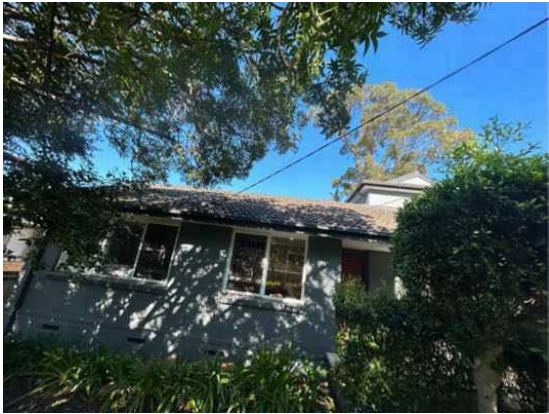
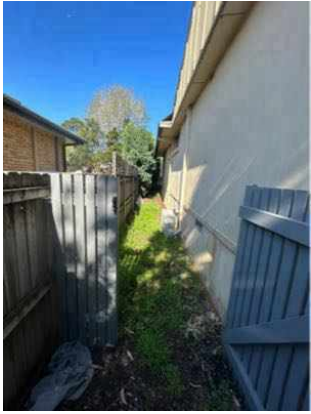
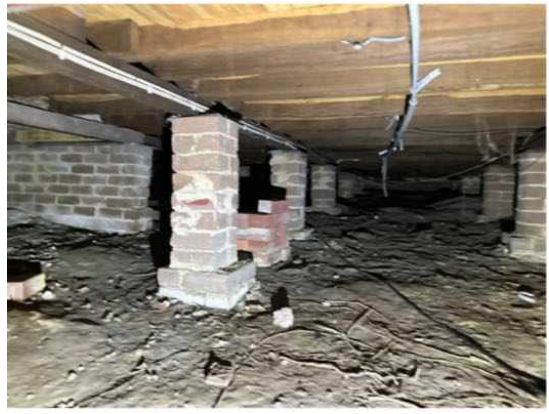
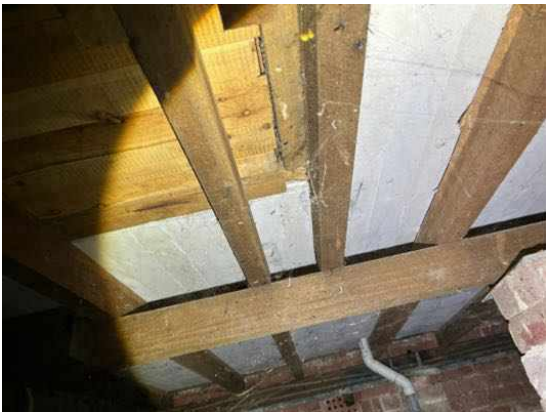
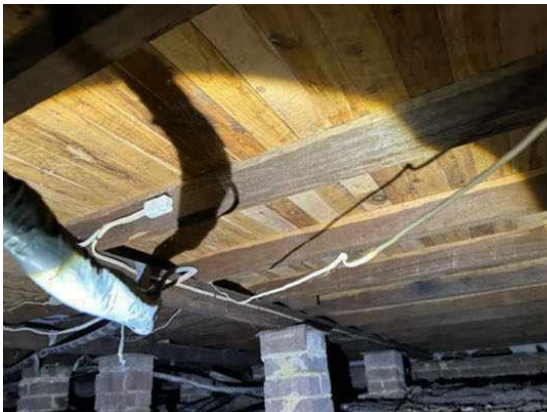
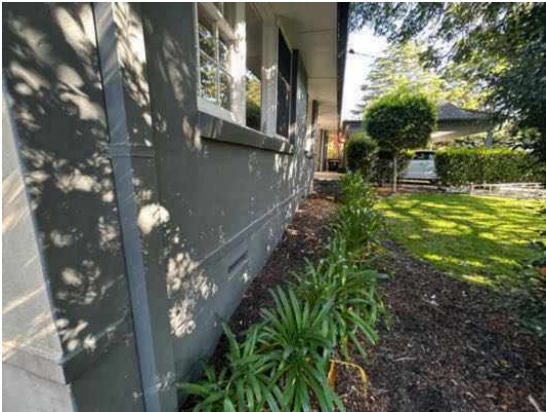
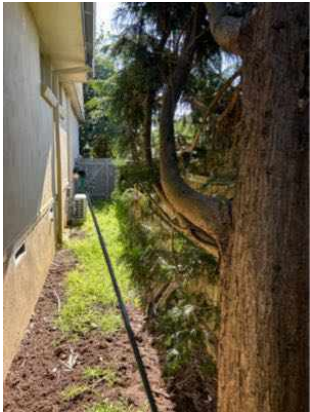
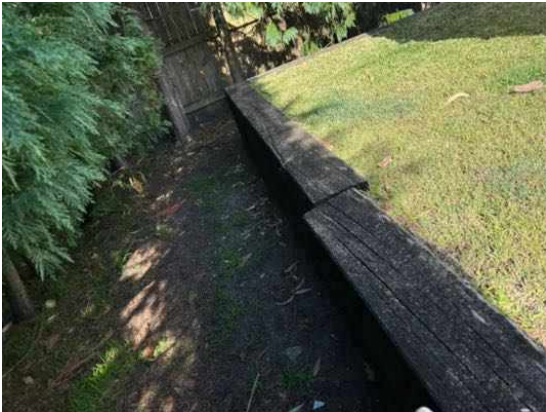
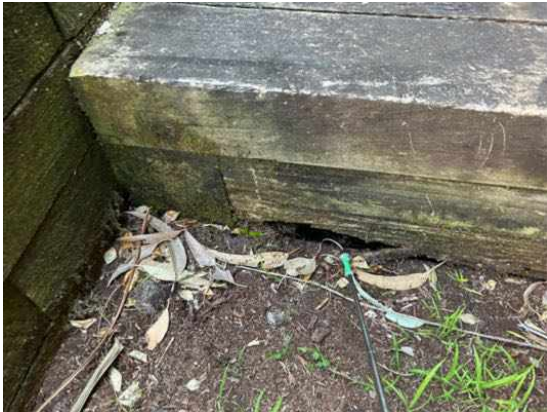
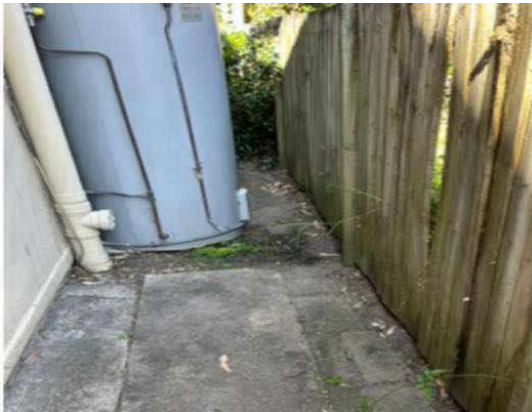
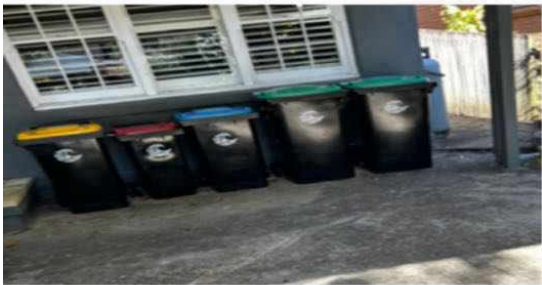
Noted Item

Building: Building 1
Location: All Areas
Finding: Additional Photos - Obstructions and Limitations
Information: These photographs are an indication of the obstructions and limitations which impeded full inspection of the property at the time of inspection. These obstructions can hide an array of defects and should be removed to allow full inspection to be carried out. A re-inspection is recommended once the areas are made accessible.

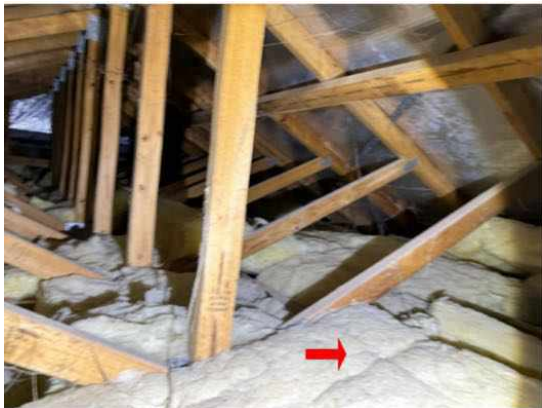
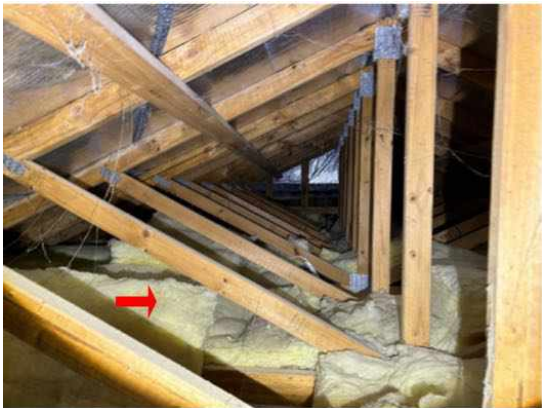
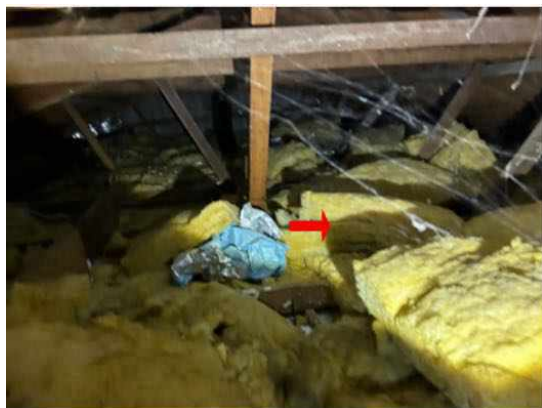
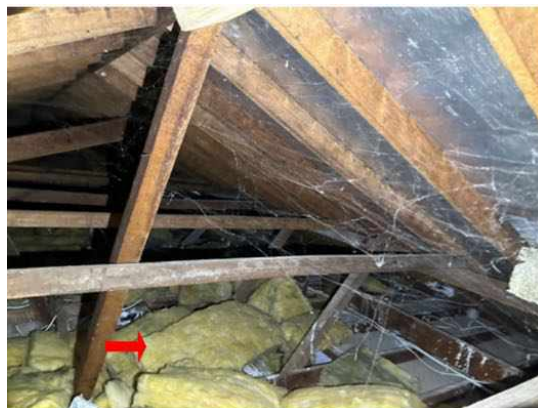
Building:	Building 1
Location:	Roof Void
Finding:	Insulation- installed
Information:	Insulation is under the roof sheeting. Insulation acts as an insulator that helps with heat reduction.

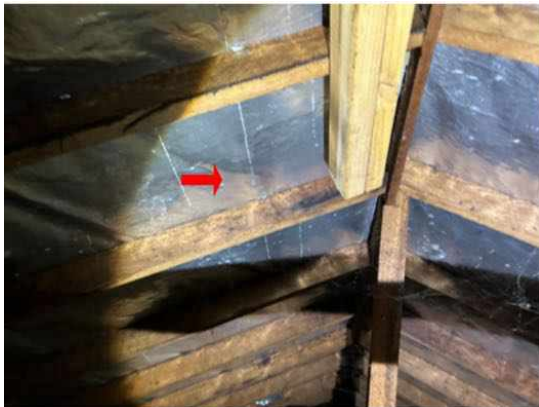
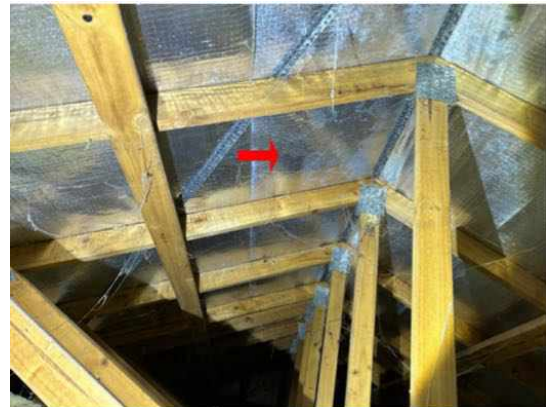
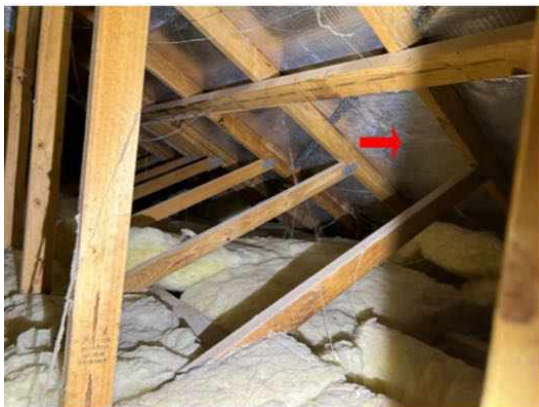
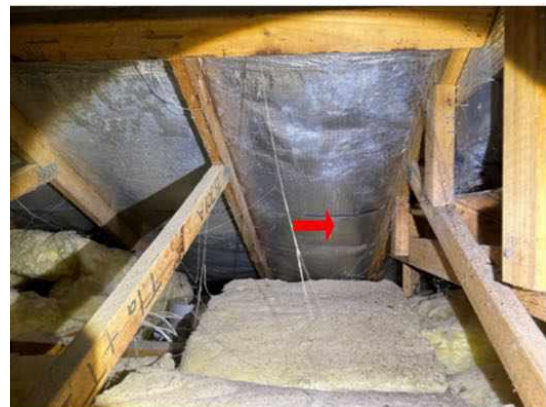
Building: Building 1
 Location: Roof Void
 Finding: Sarking - installed
 Information: Sarking is under the roof sheeting. Sarking acts as an insulator that helps with noise reduction and protects against water penetration. Sarking plays a key role in the operation and function of the overall roofing structure and its performance.
