## **VISUAL BUILDING & PEST INSPECTION REPORT**

### **Vendor Report**

**79 Lonsdale Avenue, Berowra Heights**

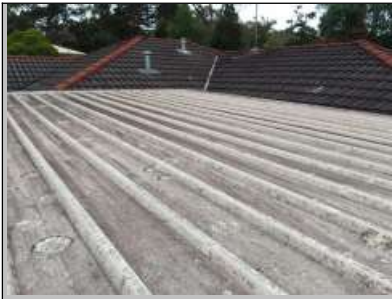
Roof Construction & Covering: The roof is of skillion style construction.

Roof Is Covered With: Metal decking.

Roof Covering Condition Detail: The overall condition of the roof coverings is good.
