Building Inspection Report

Inspection Date: Mon, 19 Aug 2019

Property Address: 11 Lee Road, Beacon Hill NSW, Australia

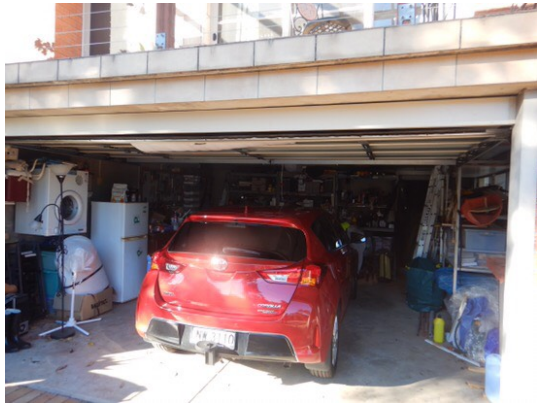
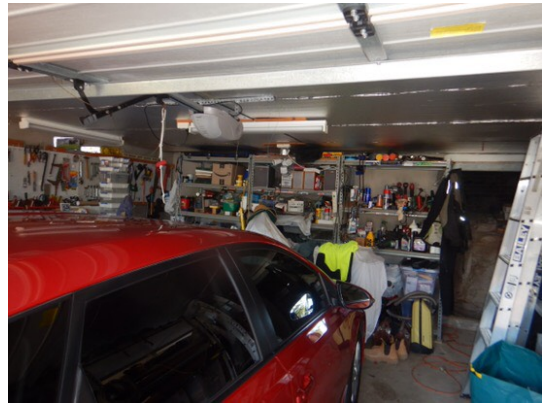
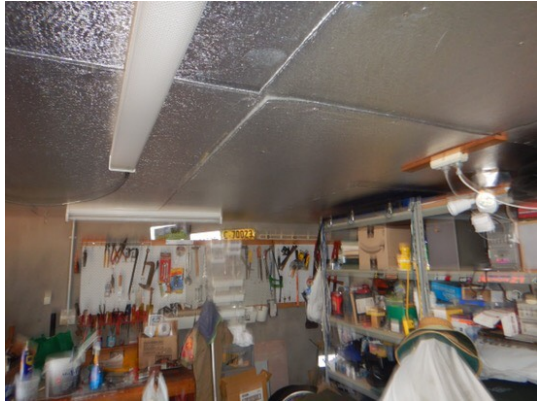
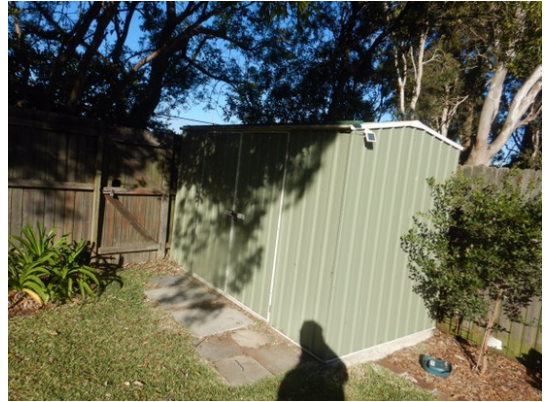
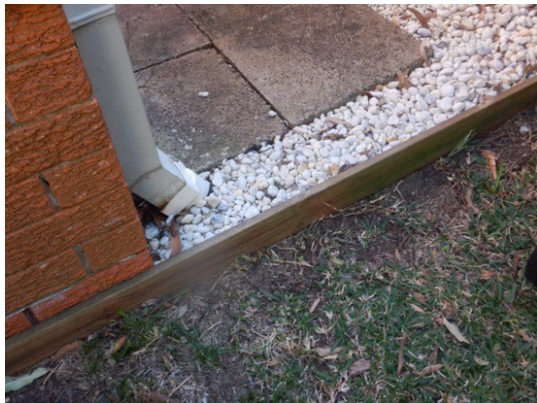
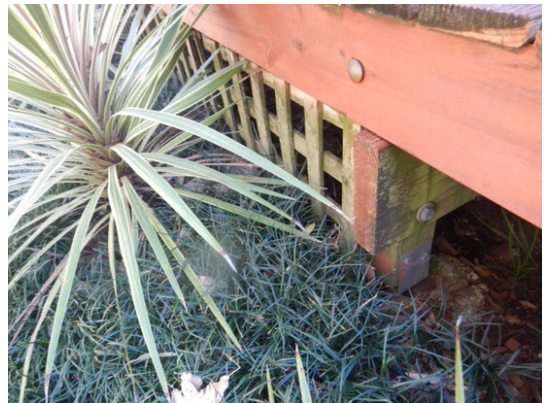
Building:	Main Building
Location:	All Areas
Finding:	Additional Photos - Obstructions and Limitations
Information:	These photographs are an indication of the obstructions and limitations which impeded full inspection of the property at the time of inspection.
