## Building and Timber Pest Inspection Report

Inspection Date: Tue, 13 Jul 2021

Property Address: 5A Gladys Ave, Frenchs Forest NSW 2086,  
Australia

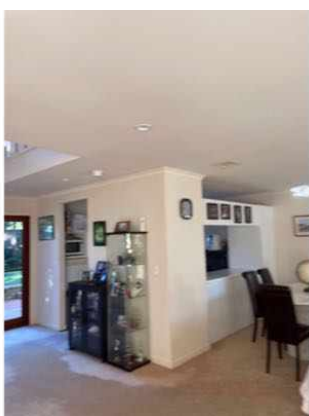
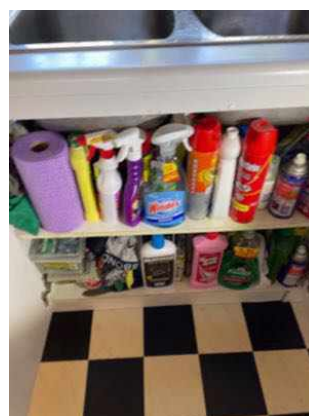
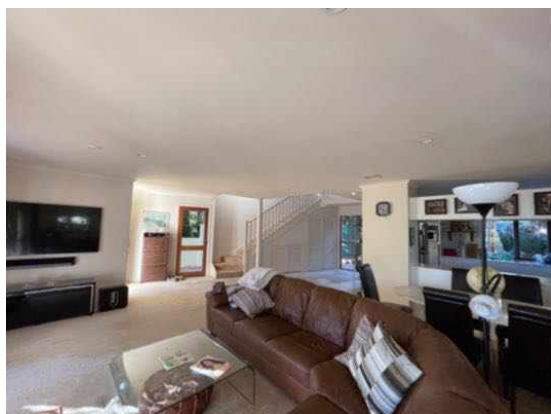
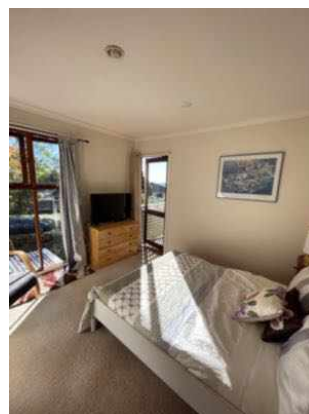
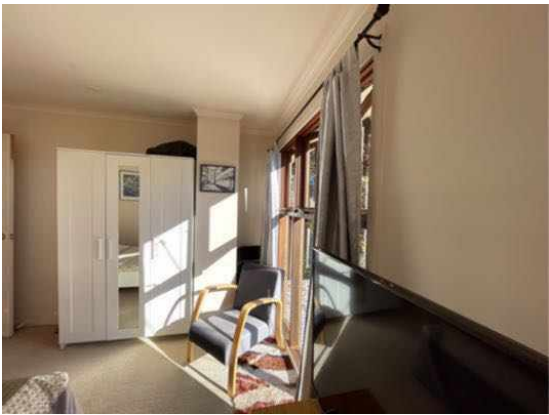
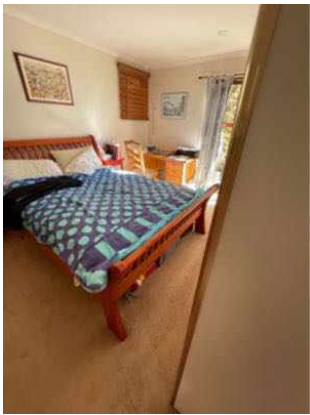
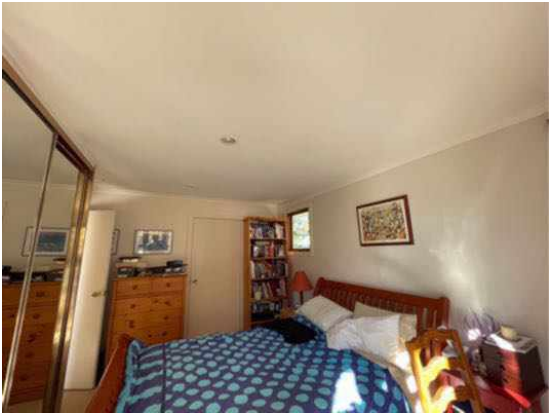
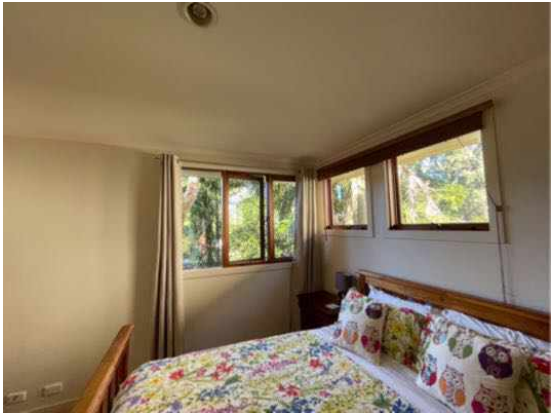
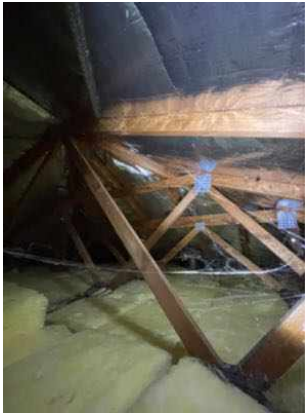
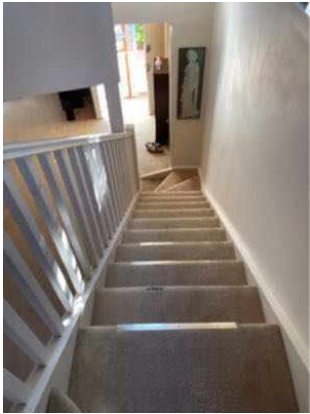
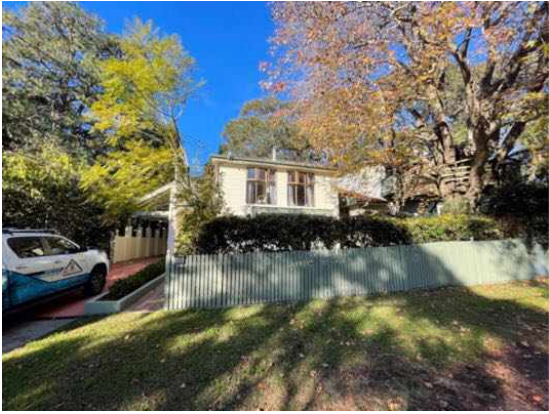
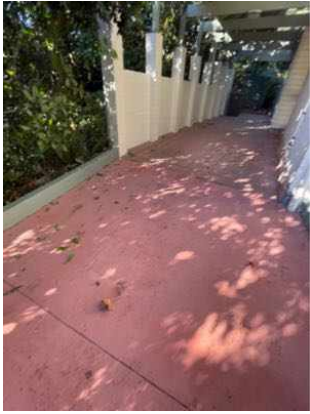
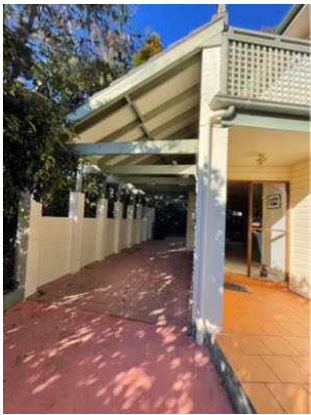
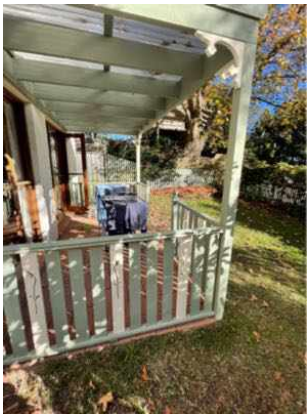
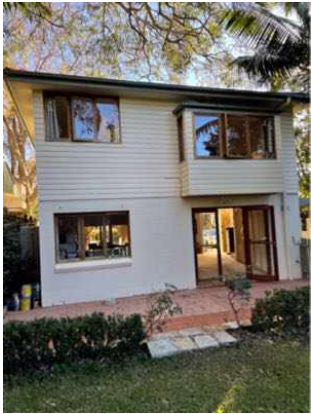
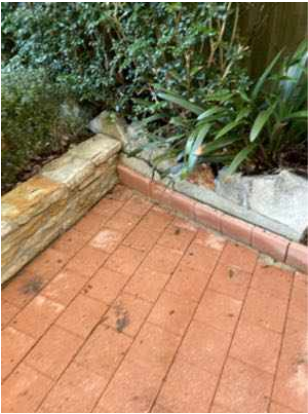
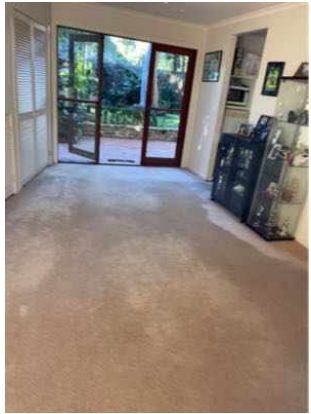
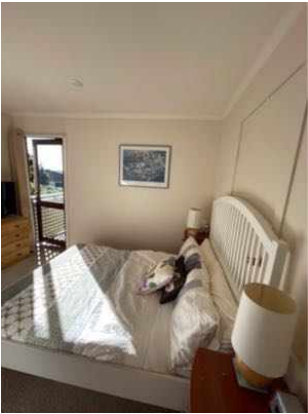
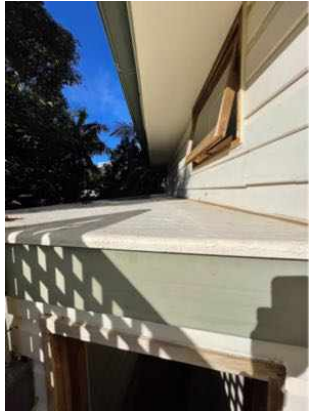
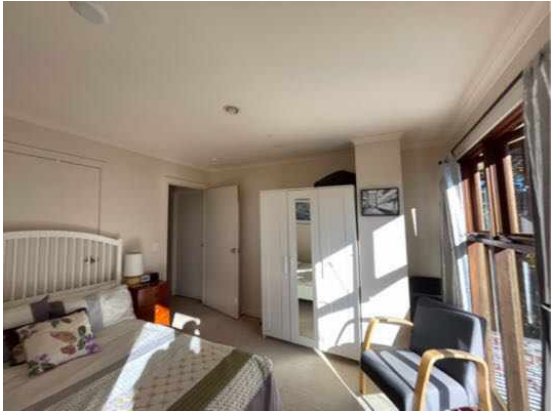
Building: Building 1  
 Location: All Areas  
 Finding: Additional Photos  
 Information: Additional photos are provided for your general reference.
