Timber Pest Inspection Report

Inspection Date: Tue, 27 Aug 2019

Property Address: 3 Tisane Avenue, Frenchs Forest NSW, Australia

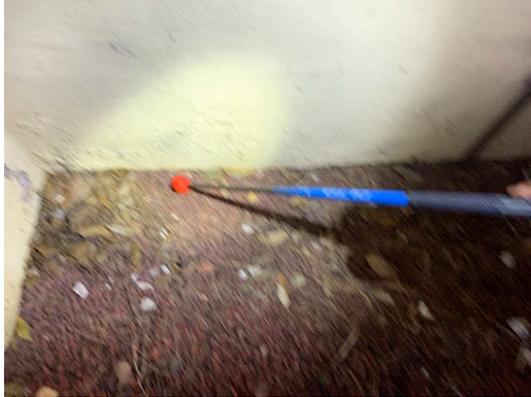
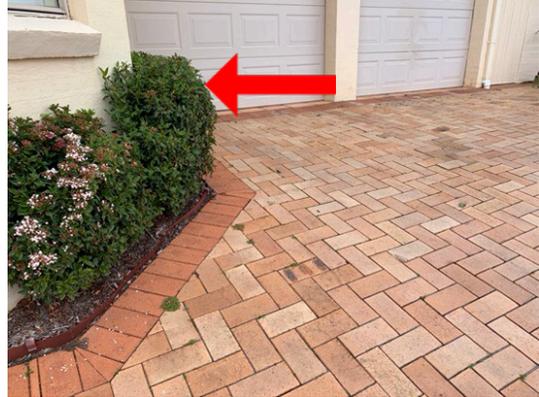
Finding: Garden Beds - Conditions Conducive to Termites

Information: Garden beds were found to be evident in the garden area. These garden beds can include untreated timber, and with a combination of moisture from watering hosing can make conditions conducive to termite activity and termite ingress.
