71 Bolwarra Avenue, West Pymble, New South Wales, 2073 Australia

Pre-Purchase Standard Property & Timber Pest Report

30th Apr, 2024

Report number:	9550778
Inspection Date:	30th Apr, 2024
Property Address	71 Bolwarra Avenue, West Pymble, New South Wales, 2073 Australia

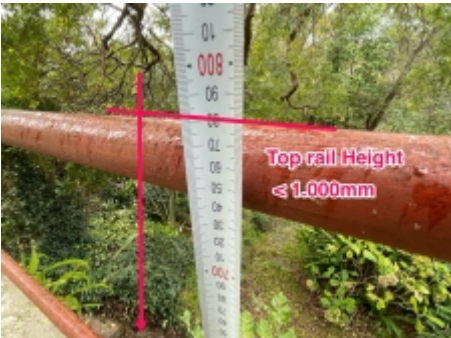
Not Compliant - BCA

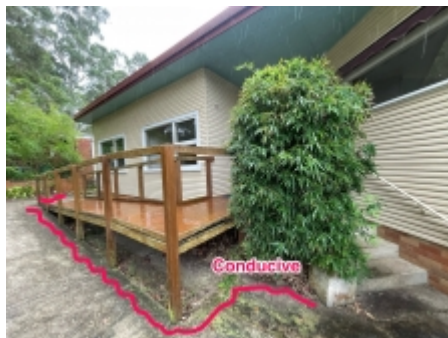
Conductive Areas
